DeLam TX

Instructions for heavy duty usage
and badly damaged floors

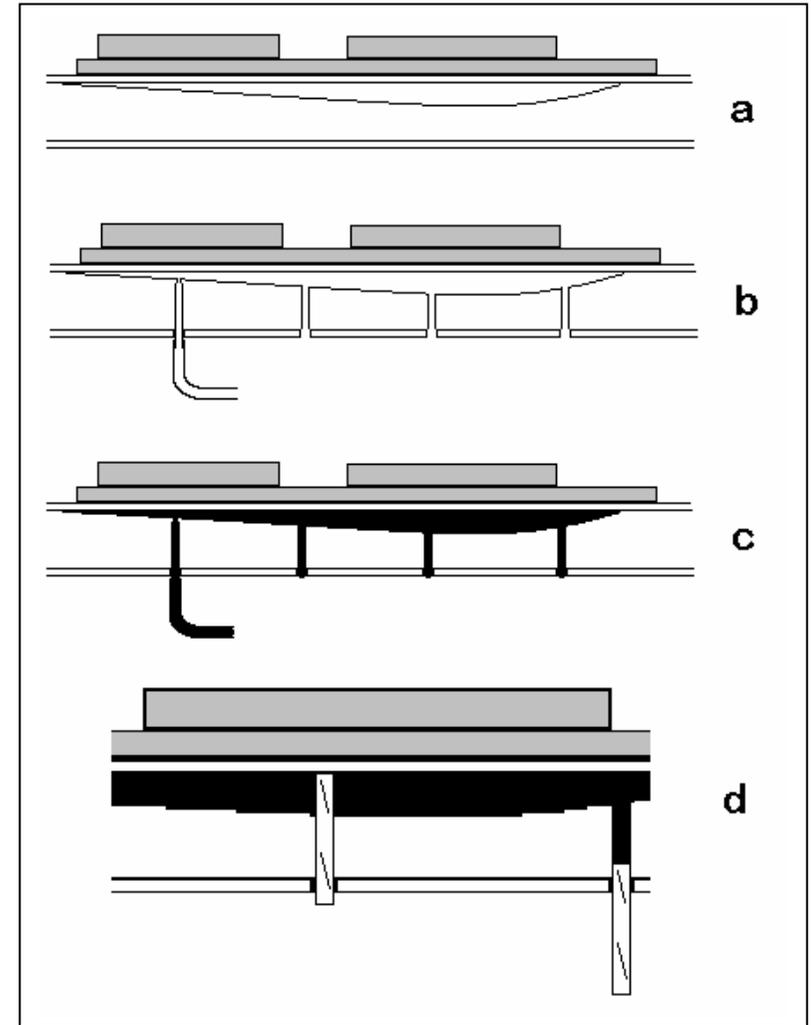
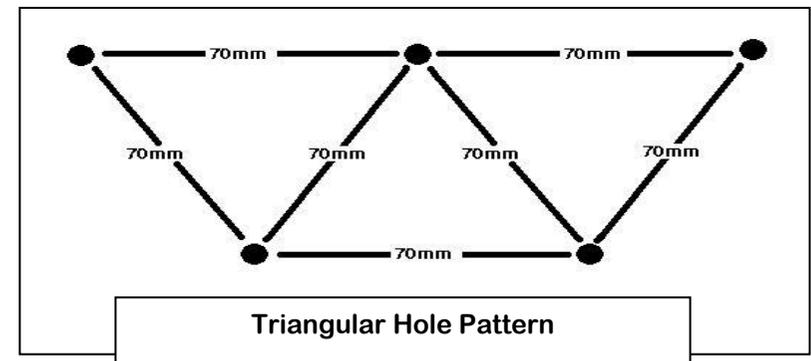
Ascertain the extent of the damaged area and mark it out on the underside of the floor. Place some large flat boards inside the caravan, over the affected area and weight it down to bring the floor to a flat surface (fig a). Drill a triangular series of 8mm holes through the lower ply and any residual insulation, at 70mm centres as per diagram. Vacuum as much debris as possible from the holes. Using a piece of wooden dowelling, check the depth of all the holes. They should all be the same. If some are shorter, adjust the weights inside the caravan until they are the same.

Cut some lengths of 8mm dowelling to the correct length. They should be long enough to touch the top ply and still sit flush to the lower ply.

Mix the DeLam TX and load it into the gun. Working methodically from the outside, inwards, inject one hole at a time, filling the void and purposely leave the hole full of resin when removing the probe (fig.c). Insert a dowel into the injected hole and tap it home to touch the top ply (fig d). The idea is to have some DeLam TX ooze of the base of the hole to glue the dowel to the lower ply. The void should be filled with DeLam TX which not only cures the hollow effect but also bonds the dowel to the top ply effectively bonding the two ply's together, reinforcing the floor.
