DeLam TX

Instructions for heavy duty usage
and badly damaged floors

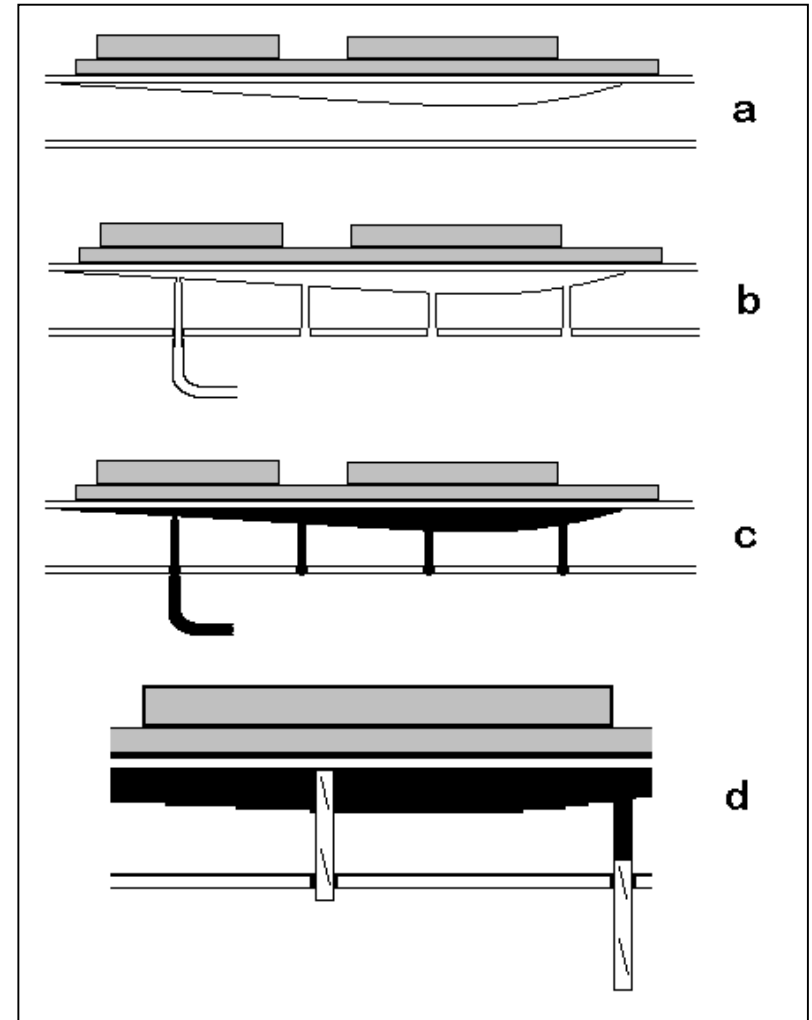
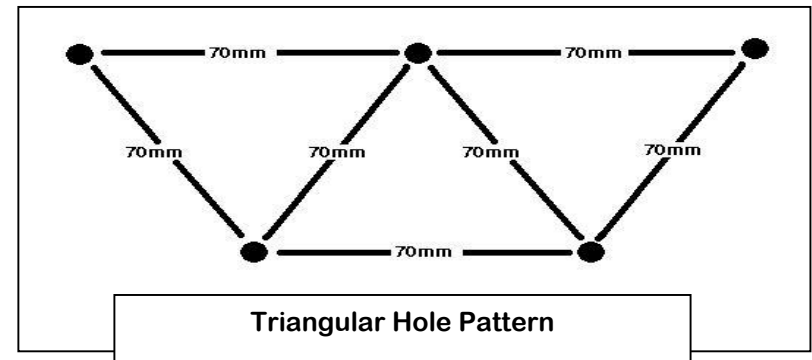
Ascertain the extent of the damaged area and mark it out on the underside of the floor. Place some large flat boards inside the caravan, over the affected area and weight it down to bring the floor to a flat surface (fig a). Drill a triangular series of 8mm holes through the lower ply and any residual insulation, at 70mm centres as per diagram. Vacuum as much debris as possible from the holes. Using a piece of wooden dowelling, check the depth of all the holes. They should all be the same. If some are shorter, adjust the weights inside the caravan until they are the same.

Mix the DeLam TX and load it into the gun. Working methodically from the outside, inwards, inject one hole at a time, filling the void and purposely leave the hole full of resin when removing the probe (fig.c). Insert a dowel into the injected hole and tap it home to touch the top ply (fig d). The idea is to have some DeLam TX ooze of the base of the hole to glue the dowel to the lower ply. The void should be filled with DeLam TX which not only cures the hollow effect but also bonds the dowel to the top ply effectively bonding the two ply's together, reinforcing the floor.

Cut some lengths of 8mm dowelling to the correct length. They should be long enough to touch the top ply and still sit flush to the lower ply.
